Channel Restoration at the Treatment Plant Arroyo in Taos

Keystone Restoration Ecology for Amigos Bravos

Dec 1, 2011

Rio Pueblo de Taos Channel Restoration

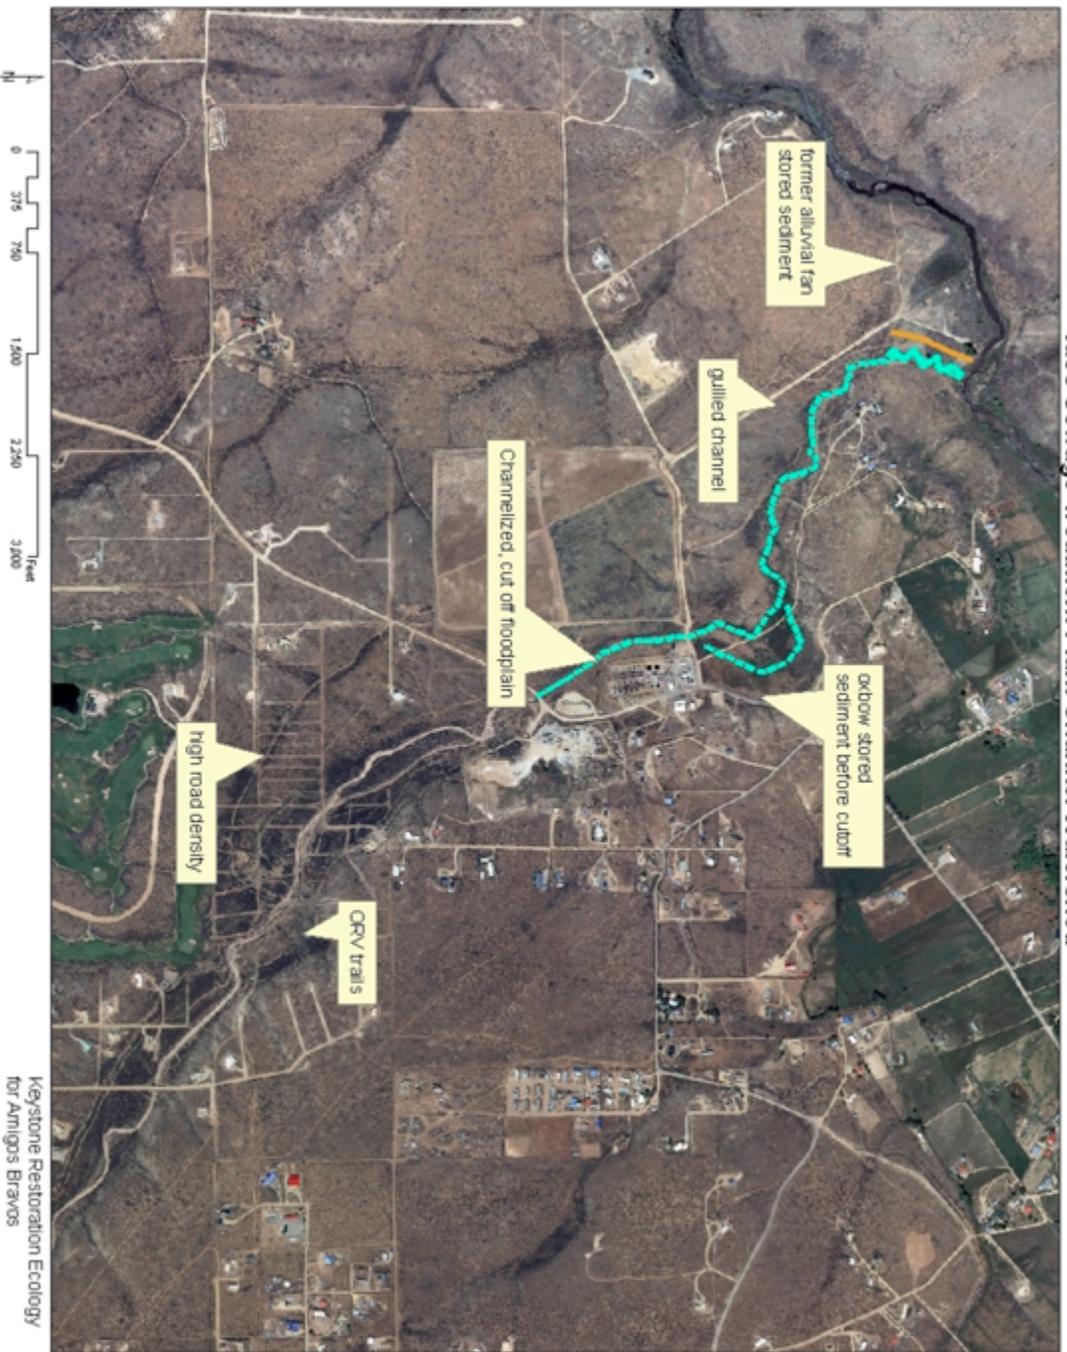
Taos Sewage Treatment Plant Channel Watershed

The Taos Valley Regional Wastewater Treatment Plant is located in the middle of the floodplain of an arroyo that drains much of the southern end of Taos. The arroyo was pushed to the western edge of the valley to protect the treatment plant, and this shortening of the channel created a steeper slope and a gully downstream from the treatment plant. The outfall from the plant flows into this gully and flows downstream to the Rio Pueblo de Taos.

The entire watershed is in poor condition, the proliferation of roads and gullies upstream contribute both sediment and water to the Treatment Plant Arroyo. In large flood events, this sediment continues downstream to the Rio Pueblo, harming the fish habitat and causing sediment problems for the river.

- Dirt road closure and drainage of roads onto healthy landforms and vegetation
- Closing 4-wheeler park and using this area to store sediment

- Repair of headcuts and gullies with hand-built rock structures and Induced Meandering

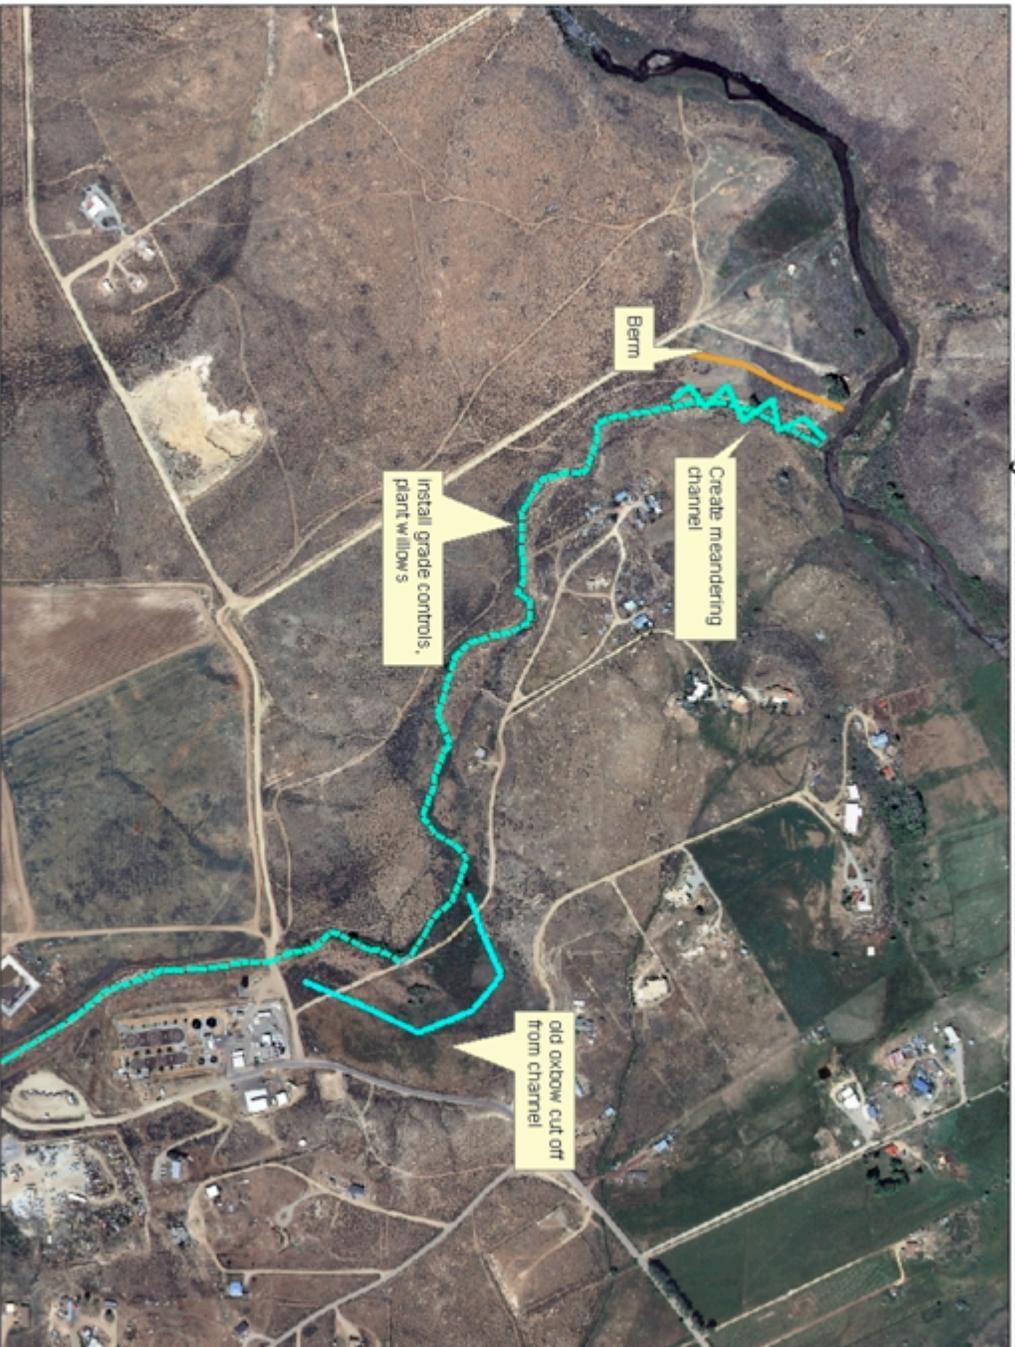
Taos Sewage Treatment Plant Channel Restoration

1. Gullied form of channel and loss of floodplain

2. Loss of alluvial fan

Some possible solutions include the addition of grade control structures in the channel to raise the water table and grow more willows and wetlands vegetation on the banks of the channel. Large flood events carrying sediment will be slowed down and buffered by this new vegetation, floodwaters will have access to the floodplain, and much less sediment will pass downstream to the river.

We propose to re-build a meandering channel in the alluvial fan by removing a large amount of sediment and using this sediment to create a berm to protect the wellfield. The removal of this sediment will create the space for both a meandering channel and a floodplain for this channel. A new, meandering channel will be dug that is appropriate to the slope and size of the watershed. Willows will be planted on the floodplain, which will be colonized quickly by wetland vegetation from the banks of the river. When floods come downstream from the upper watershed, they will spread across this newly created floodplain and the floodwaters will deposit their sediment.

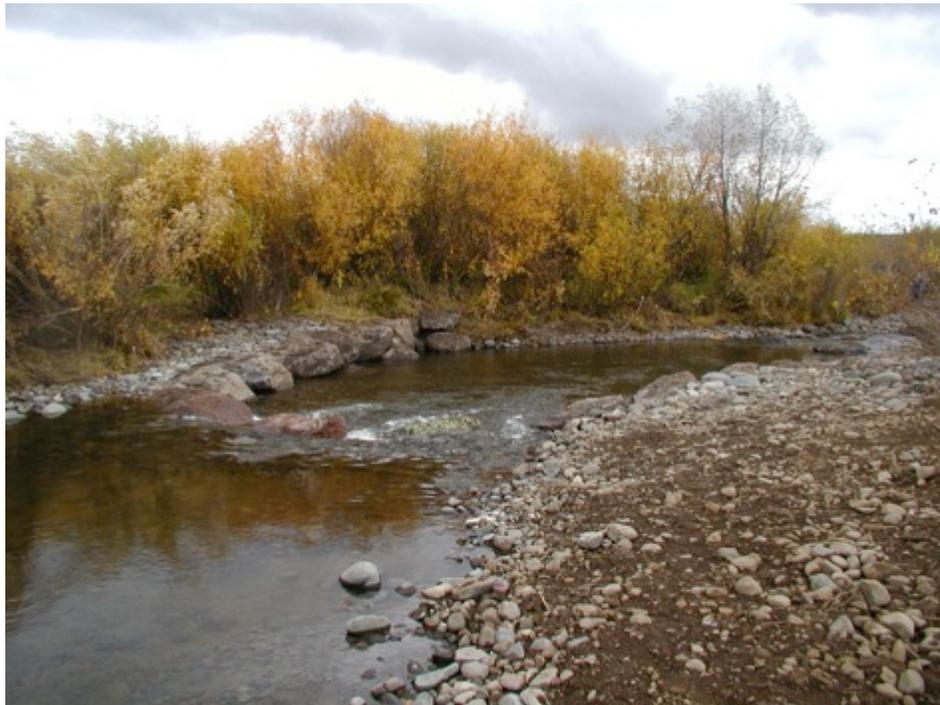
Rosgen J-Hook from upstream, eroding bank would be on left of picture

Without the agreement of a number of landowners and grazing exclusion from the river, there are smaller scale solutions to address the immediate problems of bank erosion and sediment falling into the river. The bank erosion at the upper end of the Hockmeyer property is due to straightening of the river and the increased slope, the Rio Pueblo is attempting to re-meander itself through bank erosion. Another way to disperse this excess energy is by the installation of J-Hook Vanes, which create a pool, and move the flow of the river away from the bank, slowing or stopping the bank erosion.
