# The Rio Fernando de Taos Watershed Based Plan

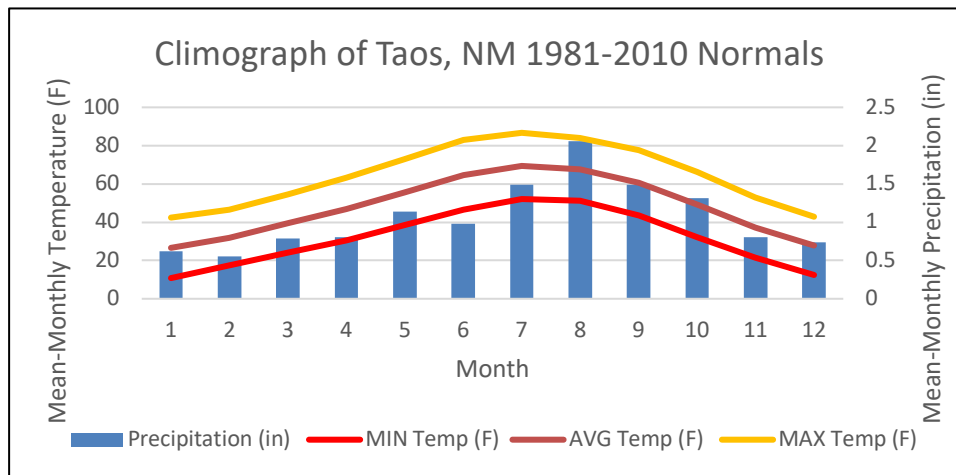
**Figure 3-7: Town of Taos Climograph; Data collected at Taos Climate Station: Elevation 6,985 feet. Climate Normals generated by National Climatic Data Center of NOAA (NOAA 2010).**

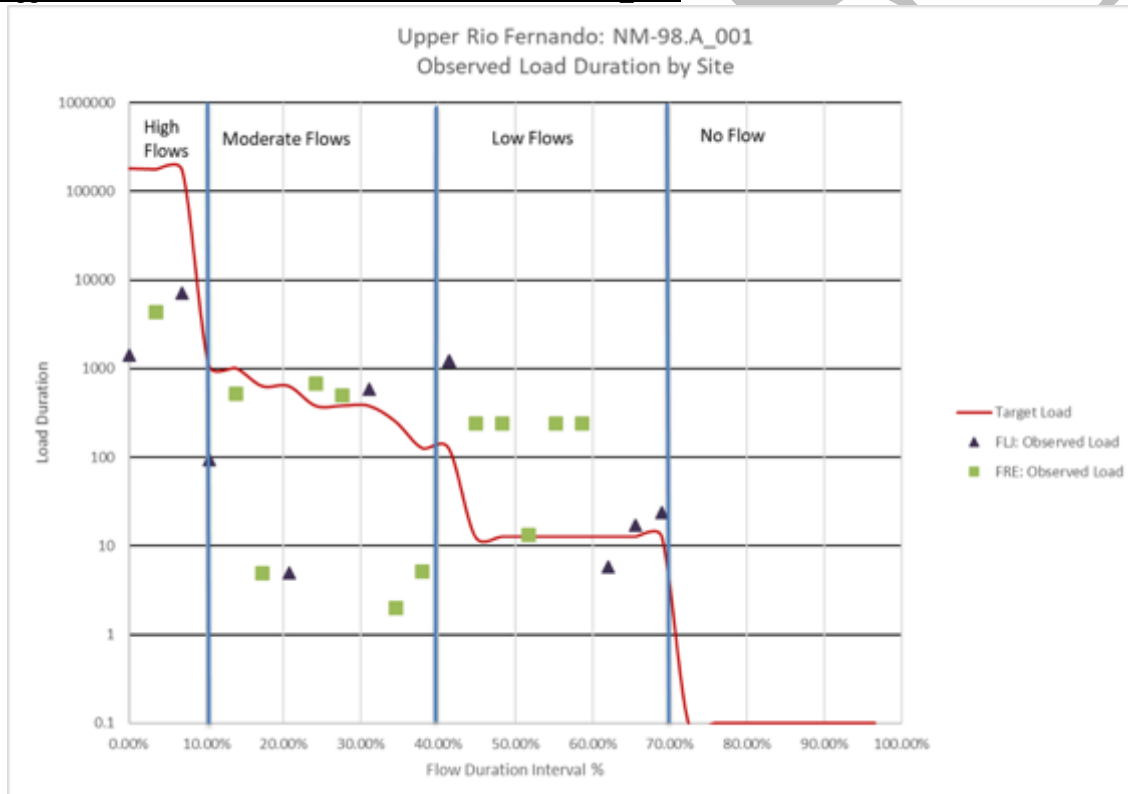
Figure 4-15: Upper Rio Fernando de Taos, Assessment Unit: NM-98.A\_001 observed load duration by site.

Exceedances observed at the FRE sample site occurred on 10/16/2017 and 5/10/2018 during moderate flow conditions. Precipitation data show there was no recent precipitation prior to either the 10/16/2017 or 5/10/2018 sampling events. This indicates the source of *E. coli* may be attributed to direct deposition of fecal matter into the stream within the riparian zone. Grazing of cattle in the FRE site occurred from September 21, 2017–September 30, 2017 and August 31, 2018–October 6, 2018. In 2017, the sample was taken 16 days after cattle were present. **This and the fact that there was no precipitation before the sampling lead us to think that deposits of cattle fecal matter decomposing and wildlife are contributing source.**

Exceedances observed at the FRE sample site during low flows occurred on 7/19/2017, 8/1/2018, 8/13/2018 and 9/11/2018. As stated above, rain events occurred prior to the 7/19/2017 as well as the 8/1/2018, 8/13/2018 and 9/11/2018 sampling events. Permitted grazing of livestock does occur in the catchment area during these dates and therefore livestock as well as wildlife are likely sources of *E. coli* observed in the stream during these sampling events. **Fresh evidence of cattle activity was documented in the data sheets on 7/19/17, 8/1/18, and 9/11/18. Cattle were meant to be in this area from August 31–October 6.** The timeframe was longer than 10 days this year due to a fencing project that was in process. The fence will be back up following the 2019 grazing season. Because of precipitation prior to the sample events, it is likely runoff carried fecal matter from both livestock and wildlife within the catchment area to the stream.

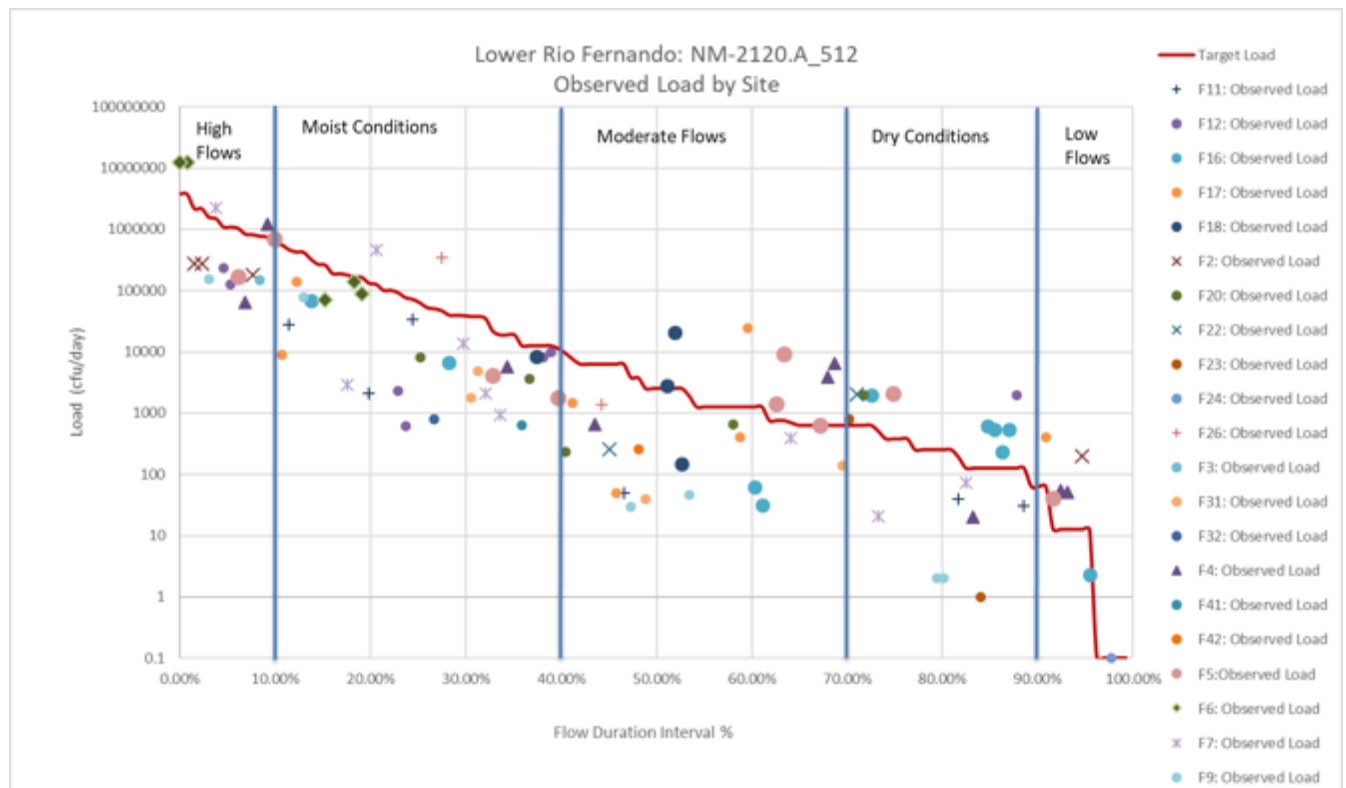
Figure 4-13: Lower Rio Fernando de Taos: Assessment Unit: NM-2120.A\_512 observed load duration by site.

Analysis of the load duration curve constructed for the Lower RFdT allows us to see several patterns of *E. coli* pollution within the lower watershed. Plotting observed load categorized by sample site across the load duration curve displays the data in such a way that we can see patterns with *E. coli* exceedances at several sample sites.

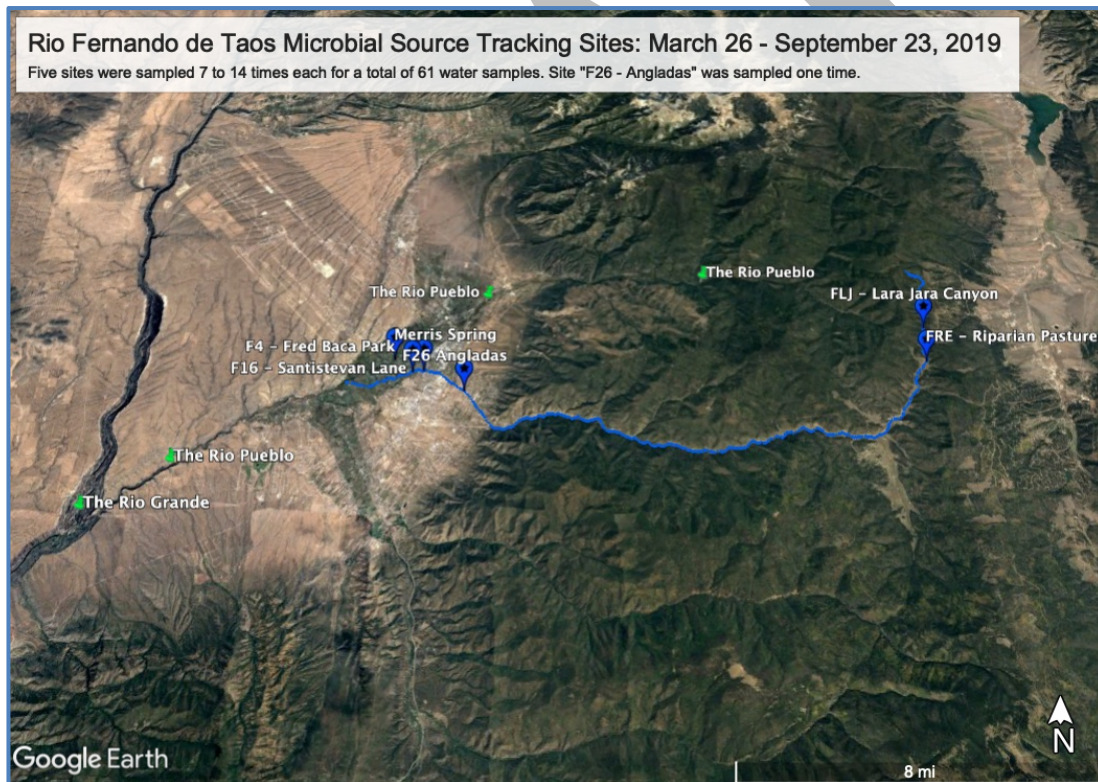
Figure 4-19: Map of Microbial Source Tracking Site Locations
