## APPENDIX A

### MICROBIAL SOURCE TRACKING TO IDENTIFY FECAL CONTAMINATION SOURCES IN THE RIO FERNANDO DE TAOS

#### TAOS, NM

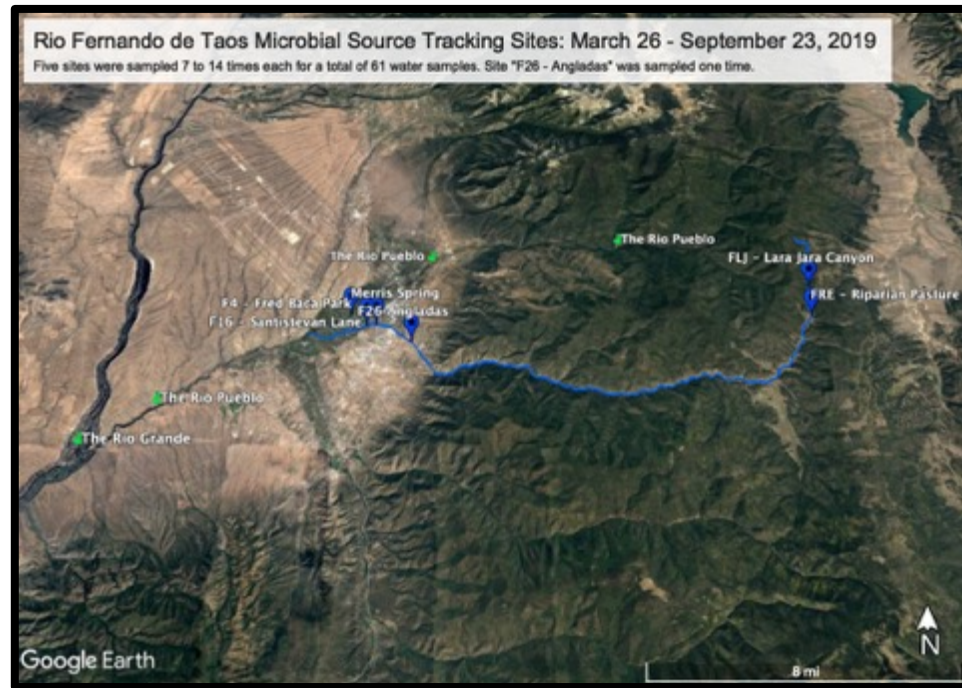
**Figure 3:** Rio Fernando MST Sample Site Map. Map of MST sampling locations. F26 was only sampled once. The other five sites were sampled 7-14 times based on water availability. Sites chosen indicate there has been an on-going *E. coli* problem in that location and more information about the source was needed.

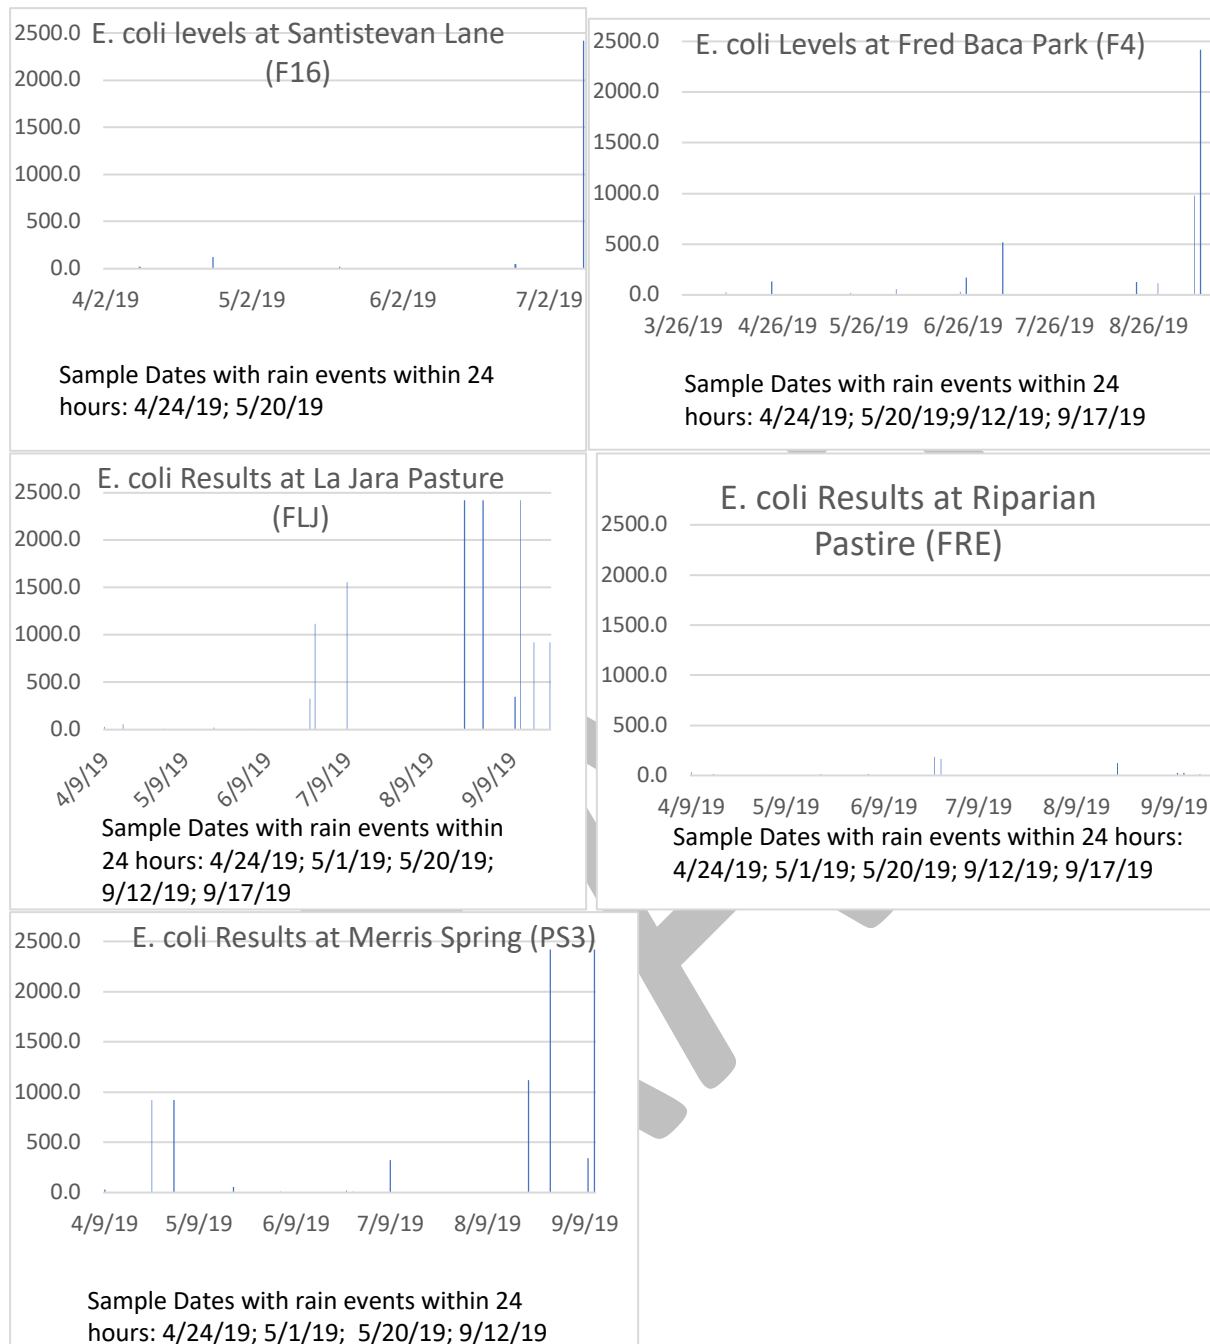
**Figure 9:** The E. coli levels found at each site on each sample day. The X-axis are the dates of sample events, the Y-axis is the level of E. coli found using IDEXX methods.

FRE is the only site that did not have any exceedances (Figure 9). While our data period excludes fall and winter, Figure 9 indicates that *E. coli* bacteria levels increased at F4, PS3, and FLJ in August and September. This timing coincides with low water levels, high recreational activity, high agricultural activity, and cattle grazing in the watershed. During the sampling period there were rain events with-in 24 hours of sampling on 4/24/19, 5/1/19, 5/20/19, 9/12/19, 9/17/19. There was not a clear pattern of *E. coli* exceedances at every site following rain events.

Bird markers were the most frequent, followed by cow. This is the only site where *E. coli* levels did not exceed water quality standards for the river on any of the sampling dates (Figure 9). Bird DNA markers were high from June – September and cow markers were highest in August and September (Figures 15 and 16). Cattle were scheduled to be grazed at this site from 9/21-9/30. However, the riparian pasture fence was down for the entire summer for replacement. We expected more frequent *E. coli* level exceedances this year due to this construction. Instead, this was one of the cleanest years (*E. coli* levels) for this site that we have seen in many years. It is possible that cattle and other wildlife behaved differently due to the construction and avoided the welding, trucks, and noise at the sample site. It is also possible that good snowpack this year helped the wetlands on the site to stay wet and better filter *E. coli* bacteria.

The pasture fence repairs are complete as of November 2019, and should limit the grazing of this pasture to the 10 allotted days. Rain events occurred on 4/24/19; 5/1/19; 5/20/19; 9/12/19; 9/17/19 (Figure 9). There was not any discernable pattern when comparing *E. coli* levels to these rain events. We sampled for human DNA markers seven times before cessation of testing because all the results were negative. Cessation of human sampling allowed us to reallocate funds for bird marker sampling. It is also important to note that elk was tested for every time but never detected (Figure 12).

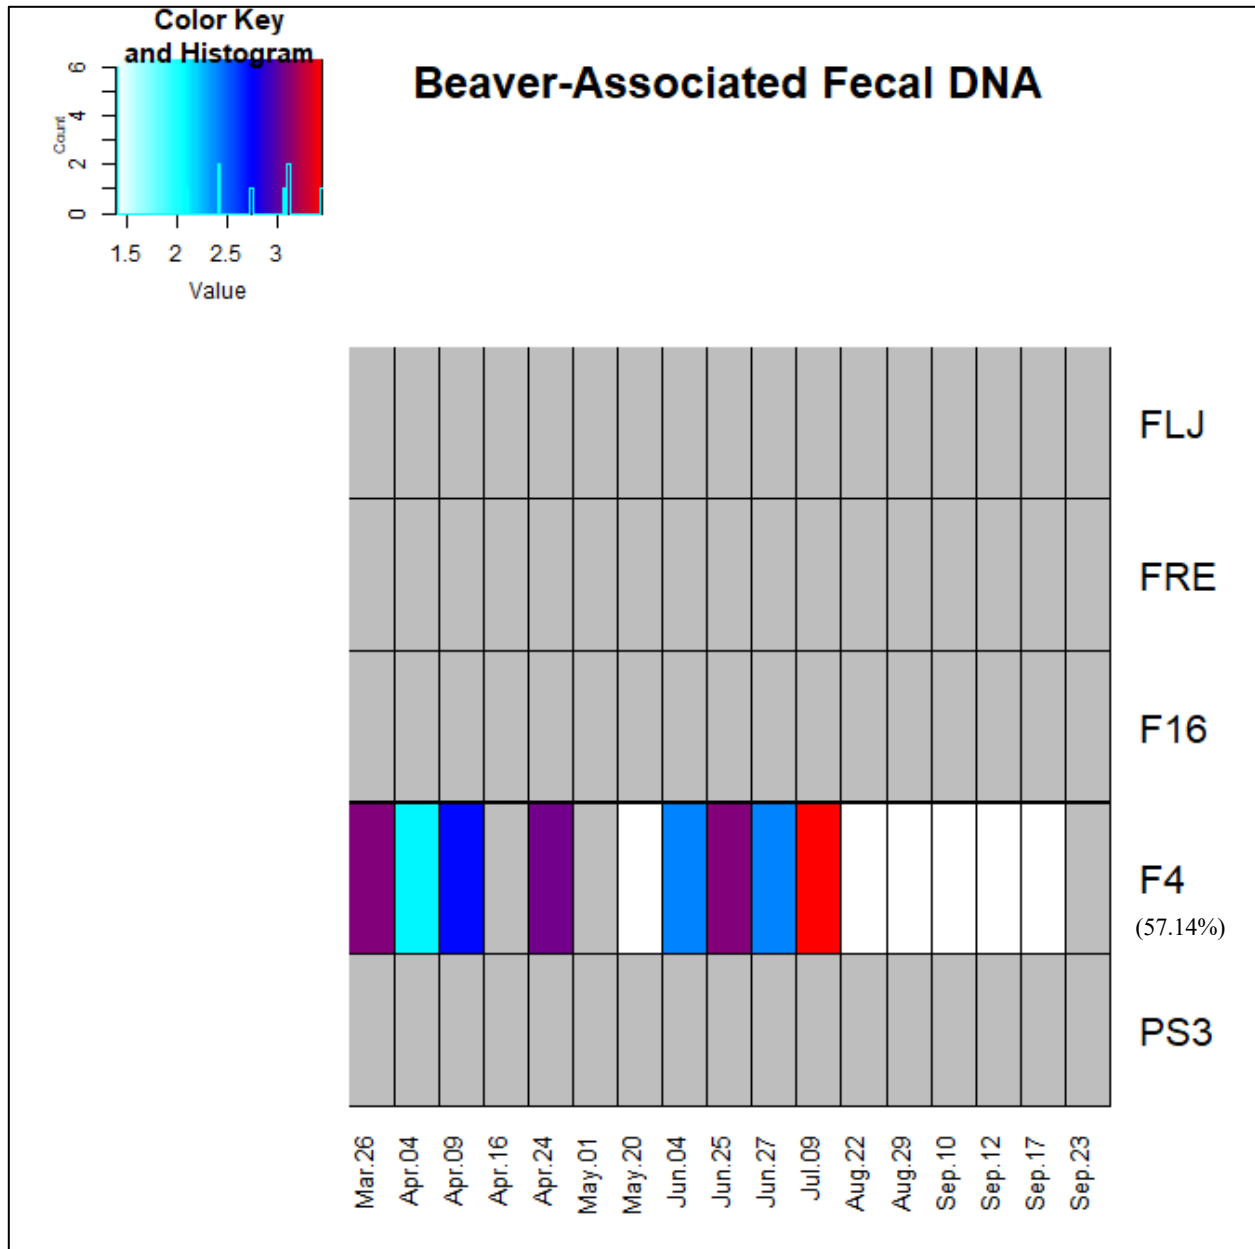
Water samples from site F4 were analyzed for a beaver-associated marker. The frequency of detection was 57%. Detections were more common in the earlier sampling events from March to July.

**Figure 17.** Gray boxes represent dates which no sample was collected at that site. Values in parentheses are frequencies of detection. Blue through red shows the level of markers found (histography provided).
