# RIO PUEBLO DE TAOS WATERSHED BASED PLAN

**December 31, 2012**

**Prepared by Rachel Conn  
of  
Amigos Bravos, Friends of the Wild Rivers.  
P.O. Box 238, Taos, NM 87571  
Amigosbravos.org  
575-758-3874**

**Submitted to the New Mexico Environment Department  
319 Grant Program  
CONTRACT # 10-667-5000-0014**

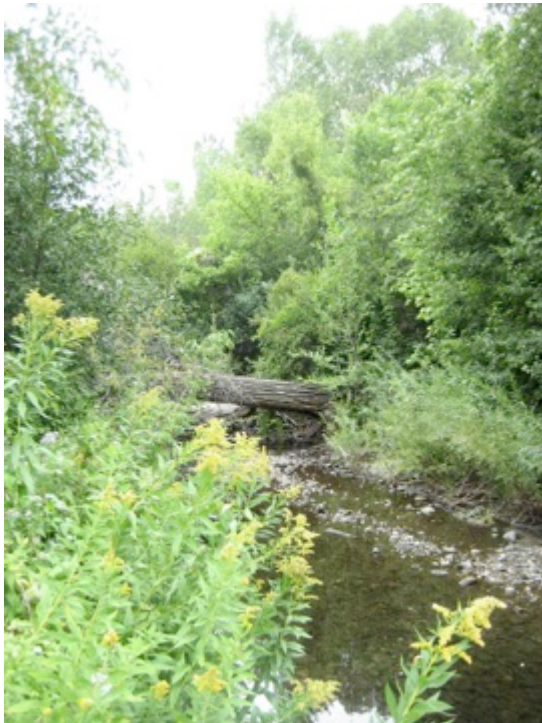
AU1S5

In the Upper Segment, where the most amount of canopy was recorded also had the most variability between sites - 90% shade found at most shaded site and 52% shade at least shaded site. All of the shade in the upper segment was from vegetation.

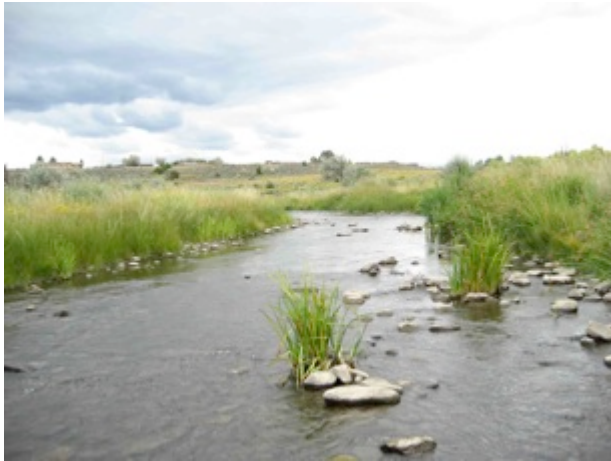
AU2S3

The middle segment also had a large amount of variability between sites - 45% shade found at most shaded site and 14% shade at least shaded site. In the Middle Segment most of the shading was from vegetation with the exception of a slight amount of shading from the canyon walls and large boulders in the lower sites in the segment.

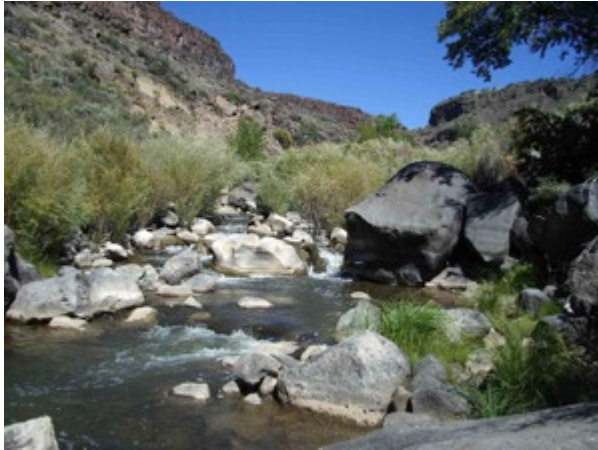
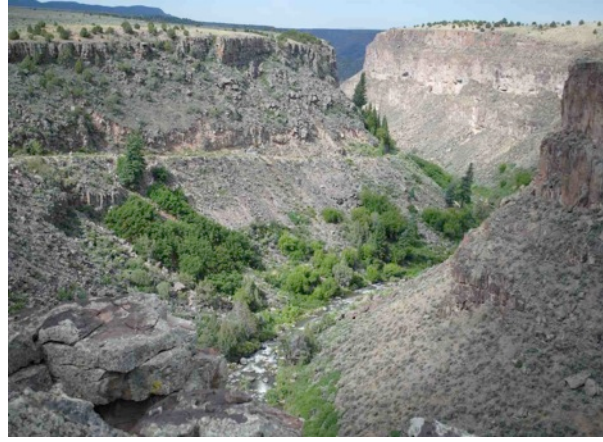
AU3 - Photos

The Lower Segment had the least amount of variability between sites - 29% shade found at most shaded site and 24% shade at least shaded site. A significant amount of shading in the sites in the Lower Segment came from the canyon walls and large boulders found in and beside the river.

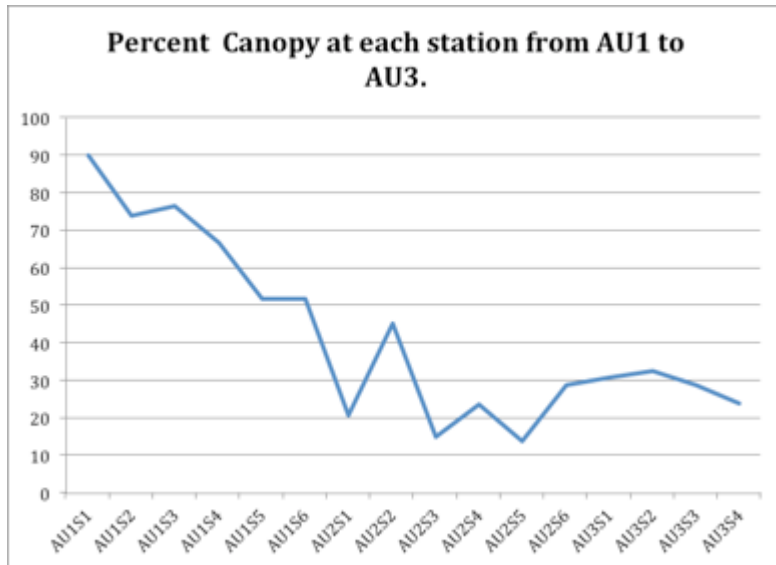
**Figure 2-1 – Percent Canopy Cover**

Overall, the trend was a decrease in canopy as we moved downstream (see Figure 2-1) though the lower segment had a bit more than the middle segment. The difference between the canopy percentages used in the TMDL and those that Amigos Bravos and watershed stakeholders measured in the field were drastic. Complete densiometer readings for all sites can be found in Appendix B.

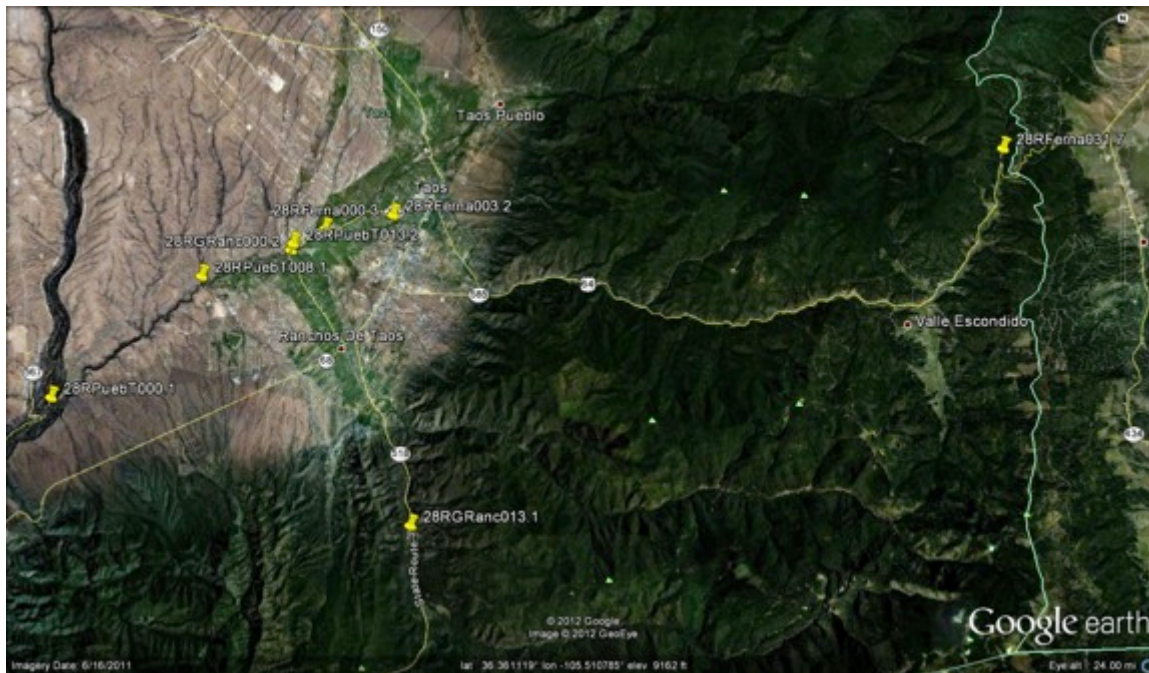
**Map 2-2 Temperature data collection sites for the Rio Pueblo de Taos, Rio Fernando, and the Rio Grande del Rancho**

Temperature data collected by NMED, BLM and Amigos Bravos with our partners show that the middle segment (AU2) is clearly the hottest stretch of the river. The temperature data collected by NMED in 2009 (Appendix D) shows that this middle segment has the highest highs and the most days, (both total and consecutive days) with more than 4 hours above 20° of any of the three AUs. Canopy data shows that AU2 also has the least amount canopy. The temperature data, canopy data, and issues of access led to our prioritizing restoration in AU2.

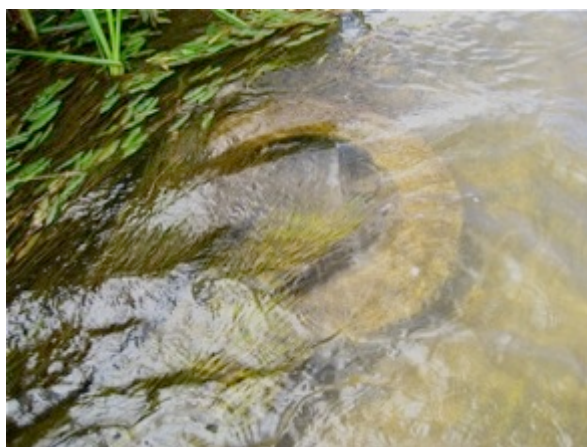
Tire in River - AU2S6

***Removal of Tires*** - During discussions with stakeholders and during the canopy measurement fieldwork it was discovered that there are many tires embedded in the stream channel. These tires embedded in the streambed could be small source of temperature loading (along with petrochemicals and other contaminant loading) as the

black color of the tires in the predominately shallow stream system could be attracting solar radiation. Work to remove an illegal deposit of thousands of tires on private property has begun, so hopefully the main source of tires in the river will soon be addressed. Unfortunately this work will not address the tires that have already made their way into the streambed. Removal of these tires, which are predominately found in the rocky canyon sections (Middle and Lower Segments) of the river will be laborious and time consuming.

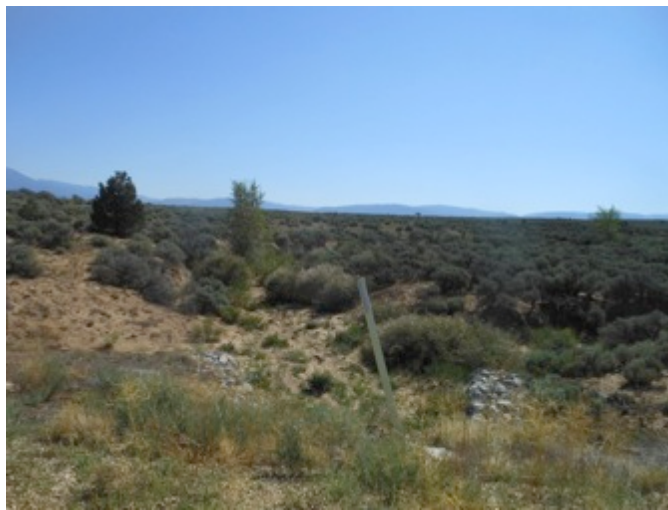
Arroyo del Alamo at HWY 570 crossing, upstream channel is not gullied and has a floodplain

Arroyo del Alamo has a few poorly installed culvert crossings low-down in the watershed (on Alamo Circle). Each of these could be treated with a “splash pad”, some rock or gabion structure to reduce scour and dissipate energy at the outlet of the culvert. There is also a “detention pond” or cattle tank fairly high in the watershed, which acts as a sediment trap for the upper half of the watershed. One headcut, also close to the Alamo Circle Area, could be treated with a “Rock Rundown” structure to prevent further migration upstream that would lengthen that small gully. This particular headcut is close to a home, so there may be important reasons other than sediment in the river to fix it.

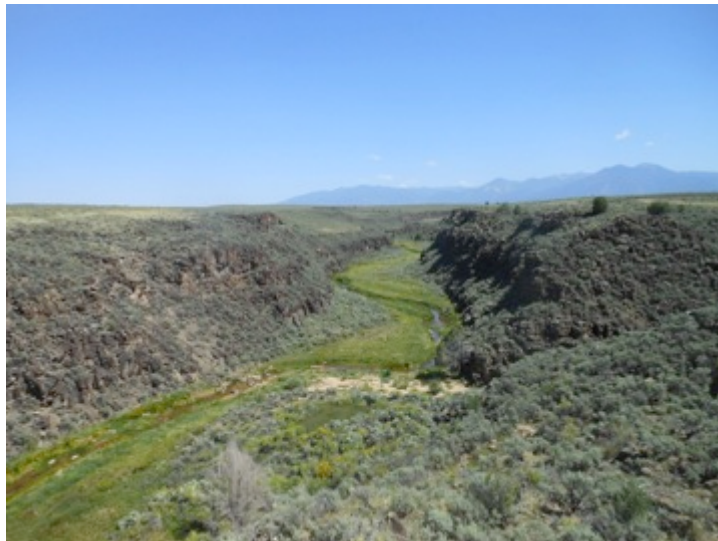
Sediment plume from Arroyo Medio into Rio Pueblo

The table above shows that there are a larger number of erosion issues on the Arroyo del Medio, and the map shows that most of these are lower down in the watershed. In particular, the presence of the “old roads” on the map is directly linked to the 5 headcuts found in the GIS assessment. Proper drainage of these old roads and the treatment of the headcuts with Rock Rundowns would address some of the major sources of sediment. The “low water arroyo crossing” column is related to a large number of un-paved high clearance roads and when they cross the arroyo, they can cause gulling upstream and mobilization of sediment. Improving these crossings with grade control structures will “hold the grade” and prevent gullyng. The one “erosive road crossing” is on the HWY 570 crossing, and the downstream end of this culvert needs a splash pad to stop erosion and dissipate flood energy.

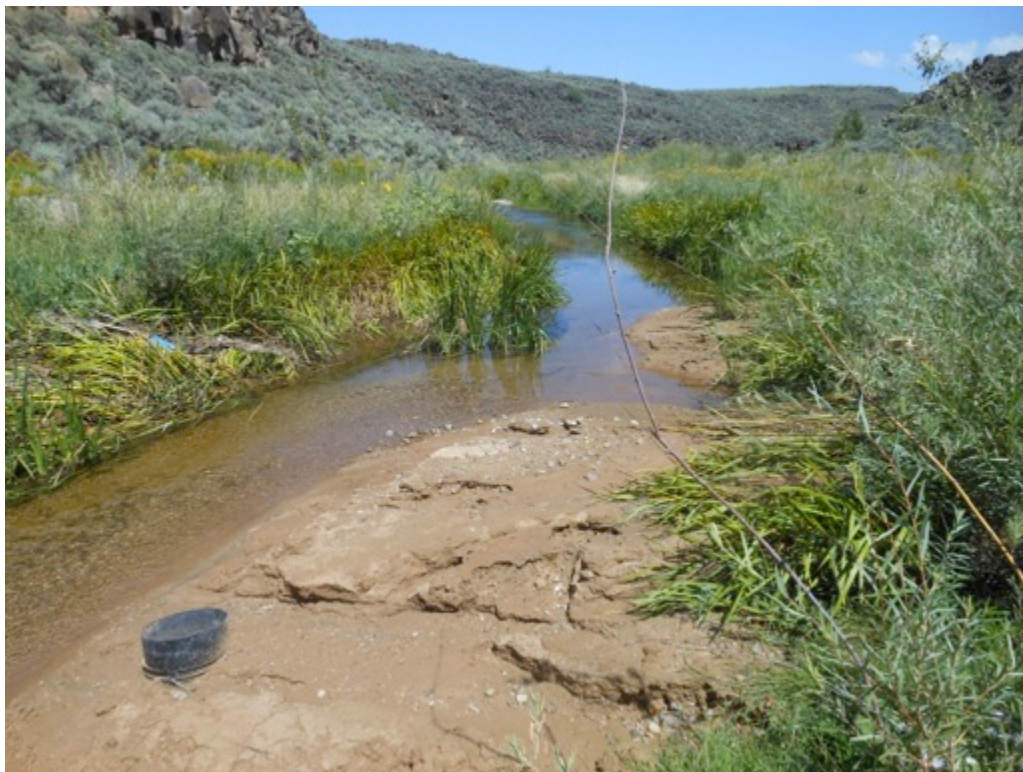
Sediment Plume in Rio Pueblo from Otter Arroyo

There are a large number of headcuts associated with the same old, abandoned roads that have caused head cutting in the Arroyo Medio Watershed. These should be treated with Rock Rundown structures to prevent further erosion upstream. Both HWY 570 and HWY 68 need splash pad structures at the culverted road crossings to dissipate energy and prevent erosion.

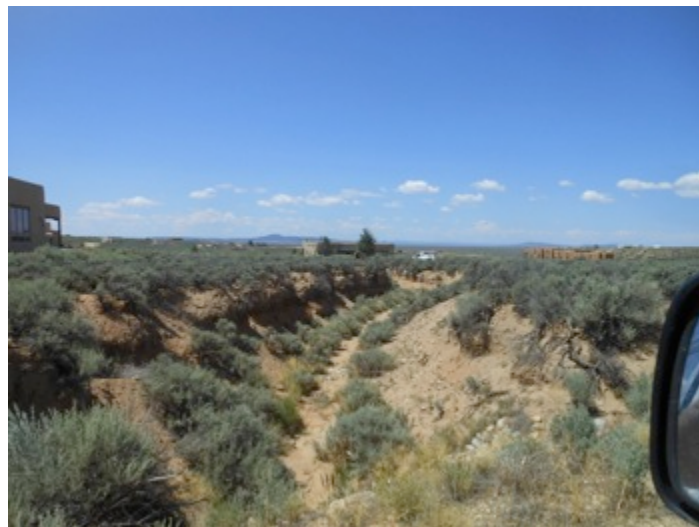
Treatment Plant Arroyo, Subdivision near Golf Course, note eroding banks

This arroyo suffers from a large amount of erosion, and is depositing this sediment into the Rio Pueblo. The large number of headcuts could be treated with Rock Rundown structures, and the nine erosive road crossings could be treated with the construction of splash pads on the downstream end of the culvert. Several unique treatments for this arroyo are listed in the 319-grant proposal. The gullied portions of this channel could be treated with the Induced Meandering design system to cause the Arroyo to meander and develop a floodplain.

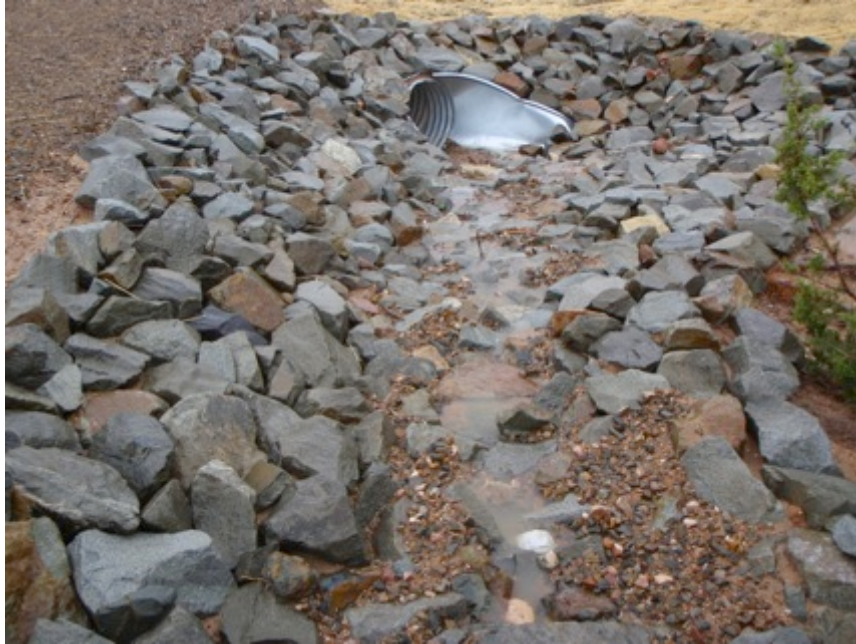
**Splash pads** - A common source of sediment and erosion is the concentration of water due to the installation of culverted road crossings. While most of these culverts are appropriately sized, during large flood events they become “water jets” that erode the downstream channel of the arroyo.

Rock Splash pad under culvert disperses force

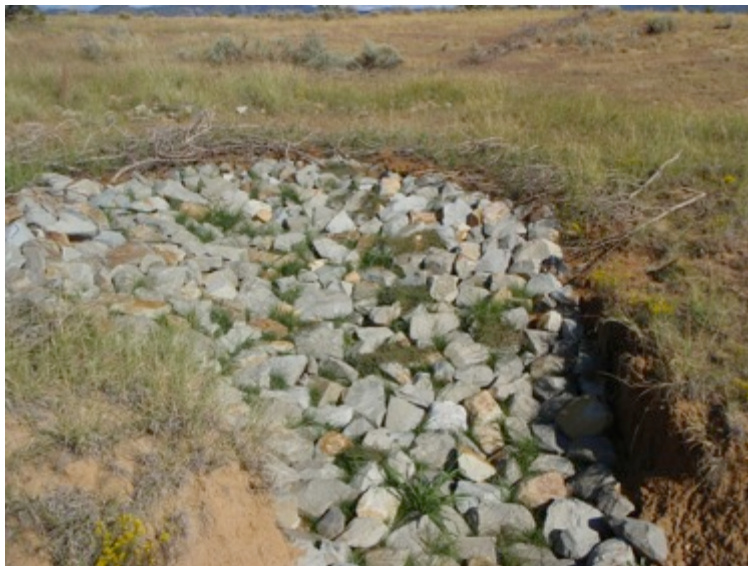
***Rock Rundowns*** - One headcut treatment that has shown to be effective over time is a Rock Rundown. This treatment involves widening and “laying back” the headcut to a 3:1 slope. Seeds are raked into the soil, and tamped into place. Rocks are laid by hand on top of this ramp to armor the surface against erosion; the rocks also act as mulch and keep the soil surface wet. Over time the growth of grass anchors the rocks and soil in place with their roots.

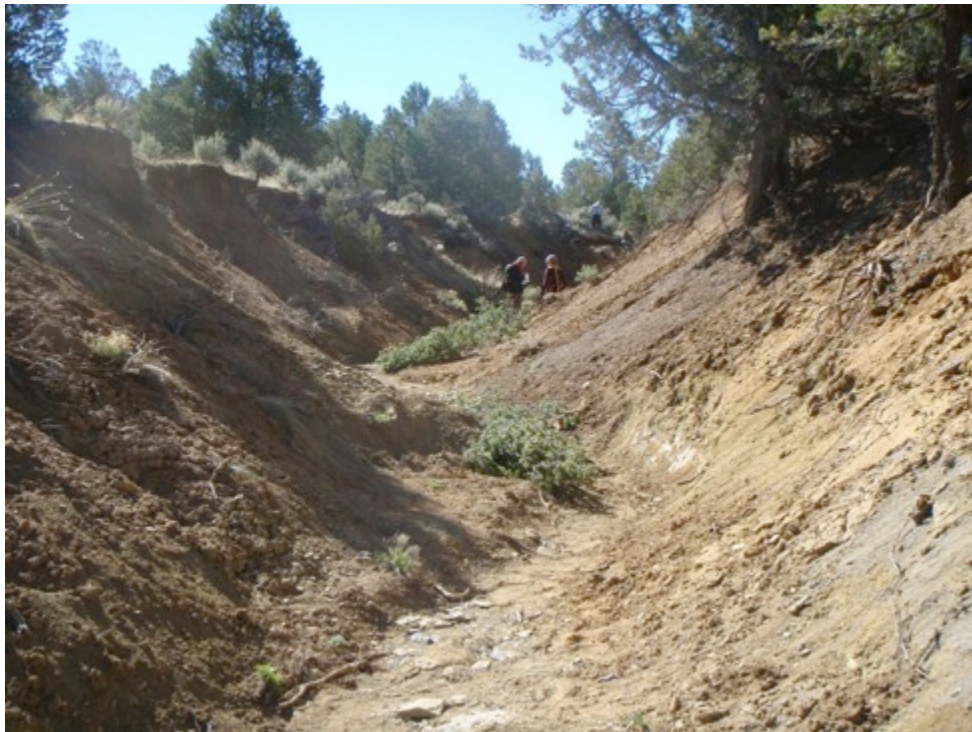
**Induced Meandering** - This technique uses the power of floodwaters to induce the arroyo to meander and create a floodplain. A gullied channel will naturally evolve to a new channel type - induced meandering speeds this process. A variety of structures can be installed to bend the arroyo first one way, and then another, in time, the capacity of the arroyo to carry floods is increased, and bank erosion is lessened.

Pinon trees used to meander an arroyo and create floodplain.

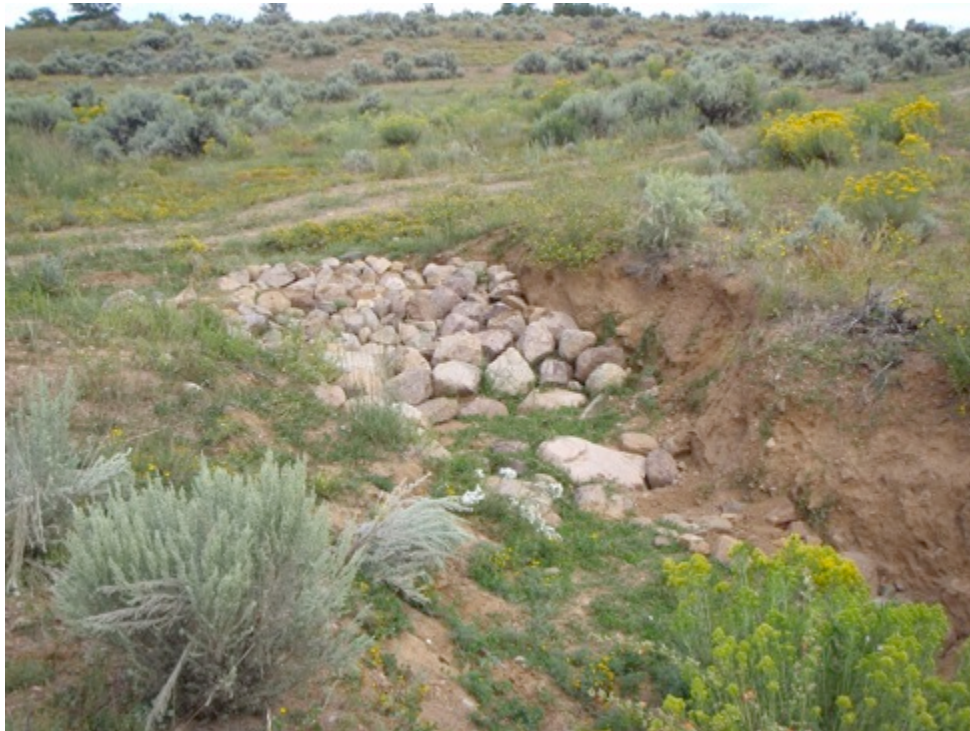
**Armoring Low Water Crossings** - A number of the dirt roads in the watersheds studied are causing erosion where they cross the arroyos. The road can concentrate water into the arroyo and cause erosion if not-properly drained uphill of the crossing. The traffic across the arroyo also causes scour on the bed of the channel, lowering the channel and sending a headcut upstream in the arroyo. Properly armoring these low water crossings can keep them passable, and prevent this erosion from occurring.

Gully formed by road, rock structure protecting road from headcut

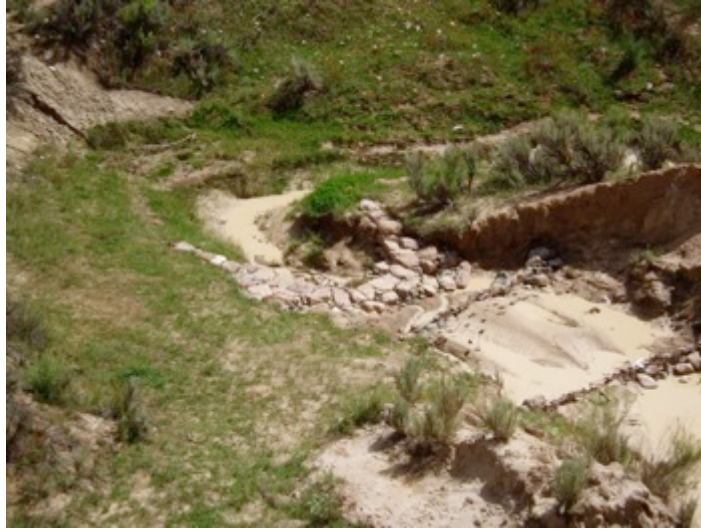
**Cross Vanes / J hooks** – Cross Vanes and J-hooks are arch-like rock structures used to prevent bank erosion and create a pool downstream of the structure. They are usually constructed from large boulders, and installed just above a bend pool at a meander bend. The vane portion of the cross vane deflects the flow away from the bank towards the scour pool. These structures are usually installed in locations where the channel needs grade control, as they are more stable than a conventional check dam structure. The need for approximately 2 cross vane / j hook structures was identified in the channel restoration priority reach.

Hand-built cross vane in Cuba, NM
